TWR-17543, Vol. VII
ECS 1012

FLIGHT SET 360T004 (STS-30) FIELD JOINT
PROTECTION SYSTEM FINAL REPORT

20 September 1989

TWR-17543 Vol. VII
Flight Set 360T004 (STS-30)
Field Joint Protection System Final Report
Volume 7
Final Report

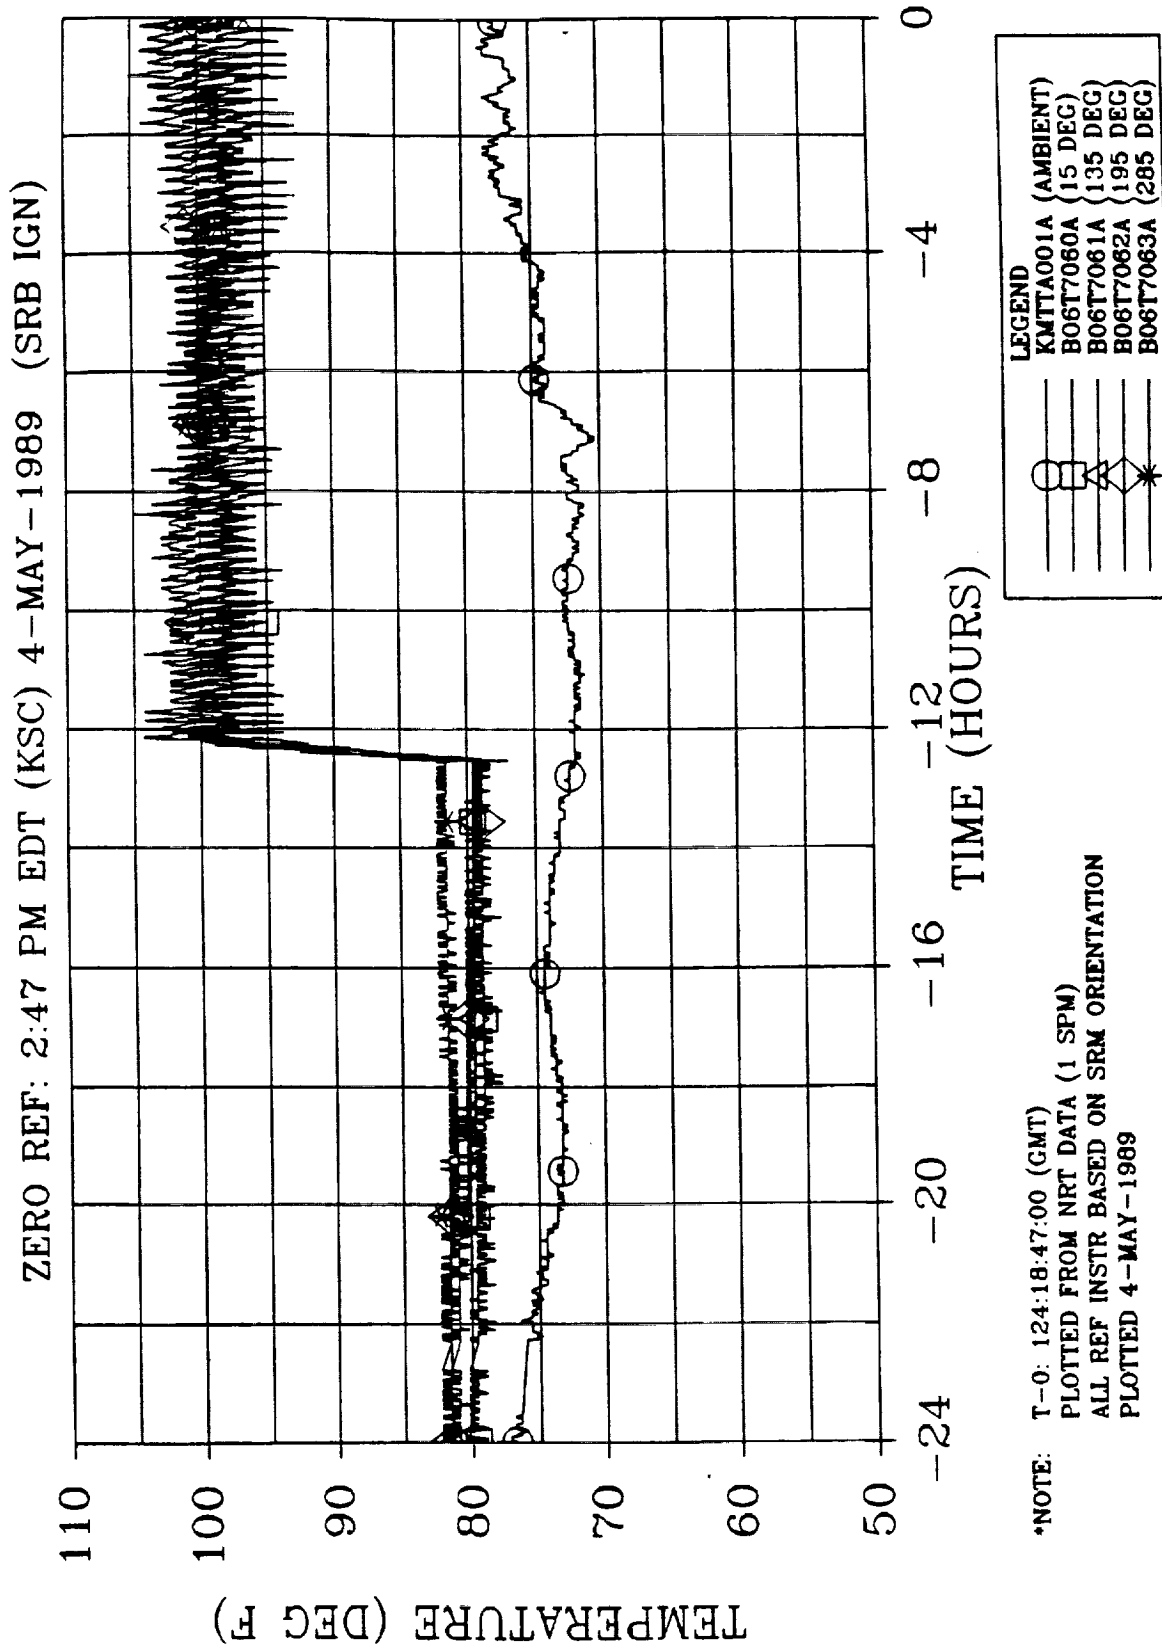
Figure 7 Left SRM Fwd Field Joint Temperature Overlaid with Ambient

Figures 7 through 9 are plots of the temperature of the four RTDs of each of the three field joints of the left SRM and Figures 10 through 12 are plots of the RTDs of the right SRM. The ambient temperature air is overlaid on the temperature plots. TWR 17543 provides an explanation for some of the observed temperature excursions.

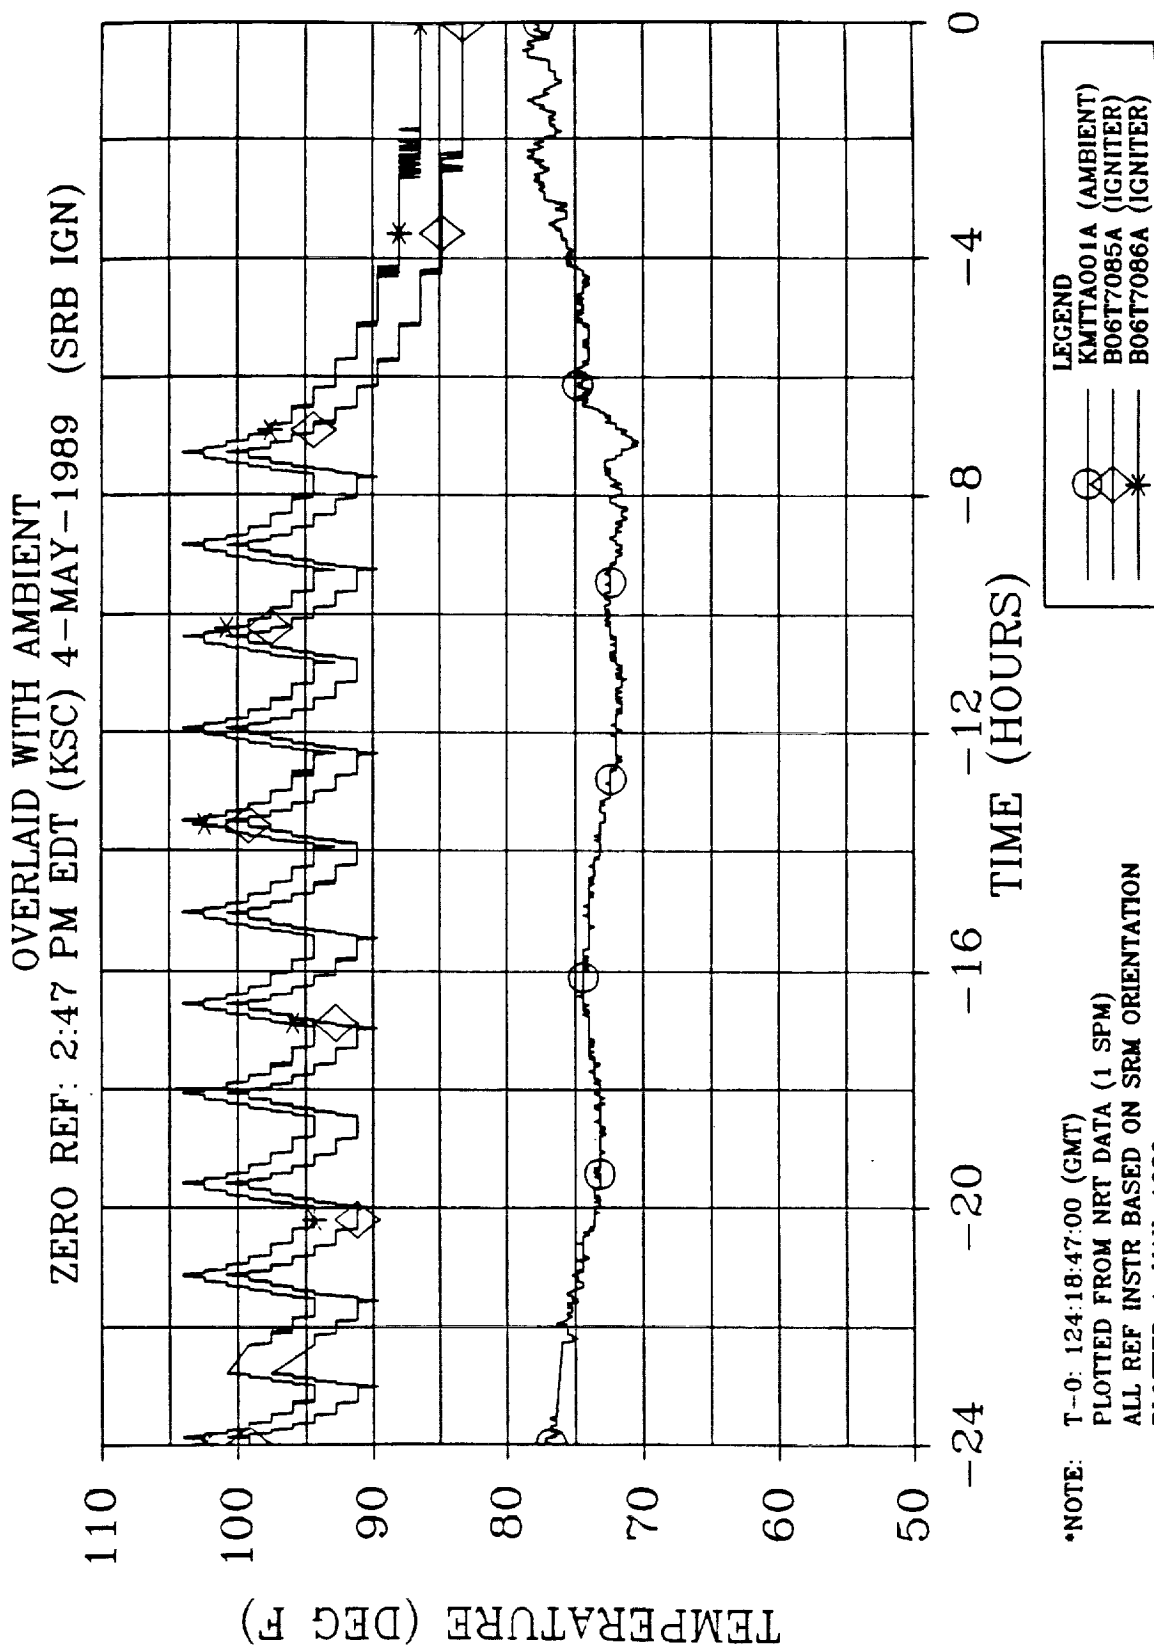
Figure 13 Left SRM Igniter Joint Temperature Overlaid with Ambient

The igniter heater installation on each motor was intact and secure. Figures 13 and 14 are the plots of the temperature at the igniter adapter. Table 28 is the evaluation checkoff worksheet for the igniter heater installation. Table 29 is the evaluation checkoff worksheet for the igniter heater components.

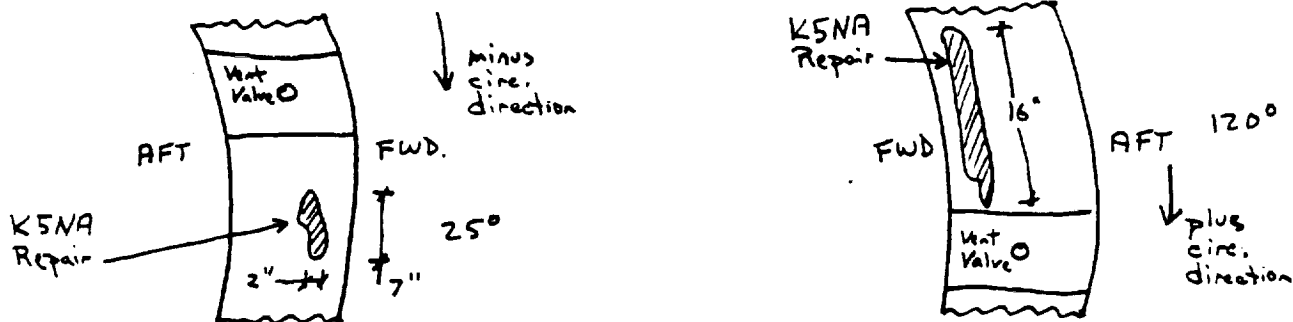
1) K5NA repairs, 1.5 in. diameter, on the leading edge where pull tests were performed pre-flight. (Repairs at 60°, 150°, 240°, and 330°).

2) ~~K5NA~~ Cork repairs were noted at 25° and 120°:

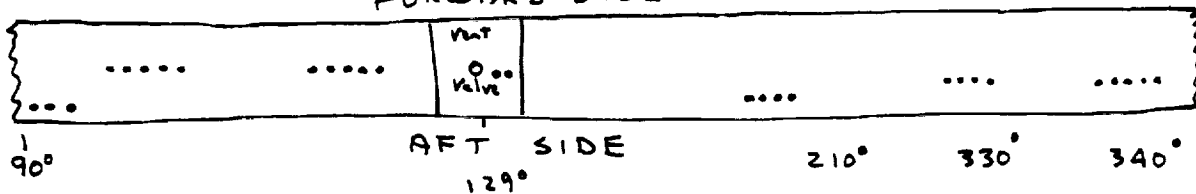
3) Additional drilled vent holes were noted as follows:
FORWARD SIDE

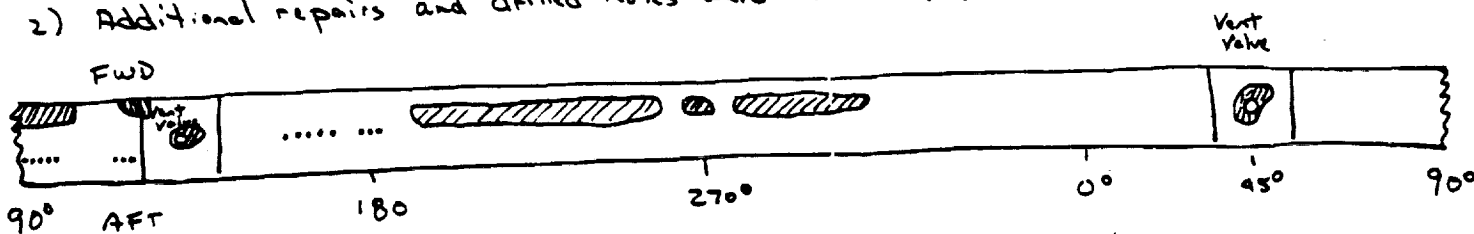
1) KSNA repairs, 1.5 in. diameter, on the leading edge where pull tests were performed pre-flight (Repairs at 60°, 150°, 240°, and 330°).
2) Additional repairs and drilled holes were noted as follows:
